Highland Roofing Company - Raleigh
4310 Deer Creek Lane
Wilmington, NC 28405
844 794 8313

INVOICE

DESCRIPTION	AMOUNT
Roof repairs have been completed per attached documentation - Suite B.	\$547.17
LPT-ID #: 649352-02150

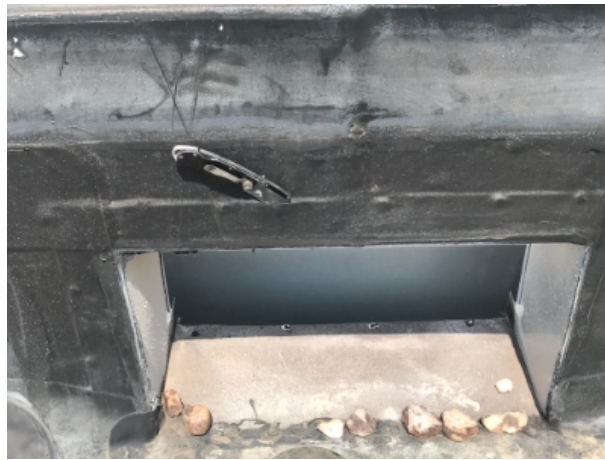
1 Problem:
Punctures - Rips -
Tears

These deficiencies are typically caused by foot traffic, mechanical work, or loose debris on the roof.

Corrective Action:

The area surrounding the deficiency was cleaned. A new piece of waterproofing membrane was installed and sealed per industry standards.

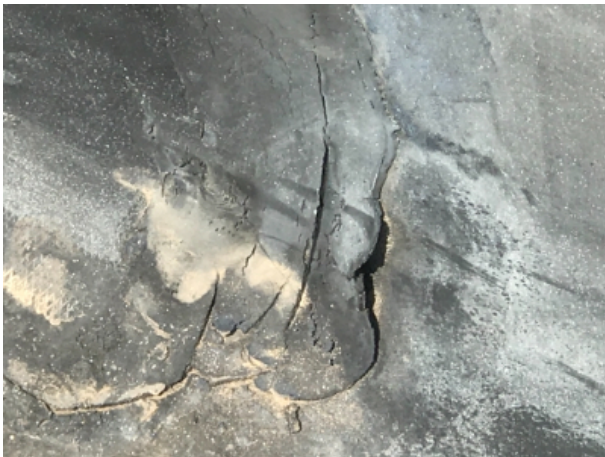
2 Problem:
Caulk / Sealant Failure

The existing caulk or sealant has failed due to age or improper application.

Corrective Action:

The old product was removed. The area was cleaned and new sealant installed as required to complete the repair.

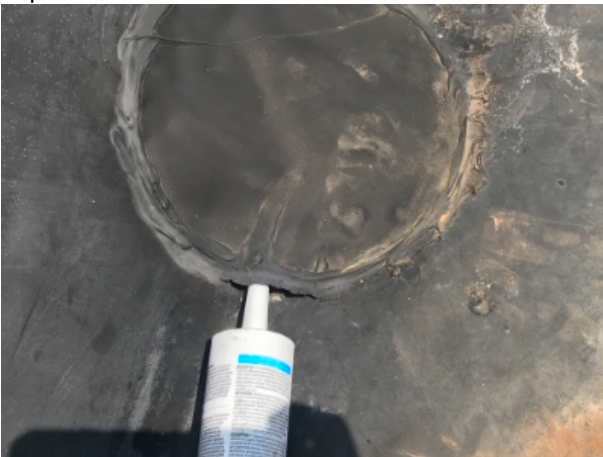
3 Problem:
Open Seams

Open seams in the waterproofing membrane are typically caused by failing seam adhesives or membrane movement over time.

Corrective Action:

The area surrounding the open seam was cleaned and sealed per industry standards.
