Management Report

Sample Company
Corporate Headquarters
4310 Deer Creek Lane, Wilmington, NC

Section: Section 1 - Front Warehouse
Size: 1,583
Overall Grade: C

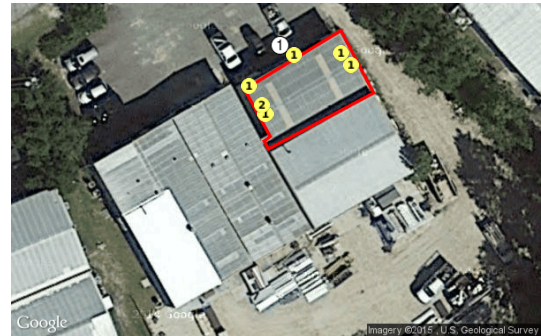
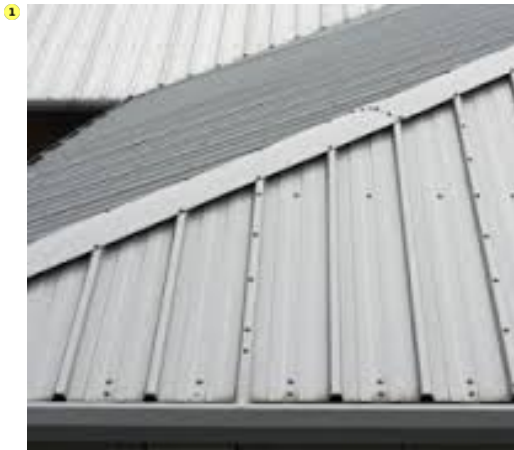
**Metal Roofing / Metal Building - Exposed fastener (Remedial)**

Quantity: 5 EA

Deficiency:

The fastener is exposed allowing deterioration and potential water ingress.

Corrective Action:

The fastener is replaced if necessary and sealant is applied to the exposed head to prevent further problems.

Estimated Repair Cost:

\$100.00

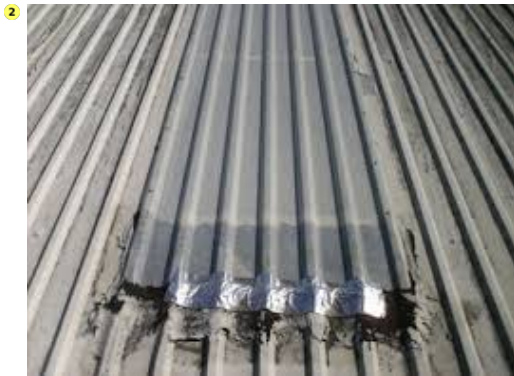
**Metal Roofing / Metal Building - Caulk / Sealant Failure (Remedial)**

Quantity: 10 LF

Deficiency:

The existing caulk or sealant has failed due to age or improper application.

Corrective Action:

The old product is removed. The area is cleaned and new sealant installed as required to complete the repair.

Estimated Repair Cost:

\$120.00

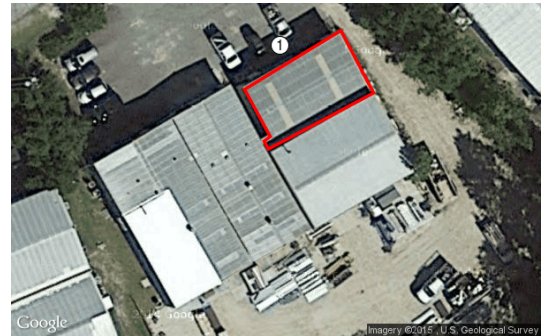
**Condition Summary**

Flashings: C
 Sheet Metal: C

Overall: C

Estimated Replacement: 2022

Estimated Repair Costs: \$845.00

Estimated Replacement Costs: \$15,829.60
