# CENTER STAGE

1116 Eastchester Drive | High Point, North Carolina

**Project Type:** Roof Replacement

**Roof System:** TPO & SSMR

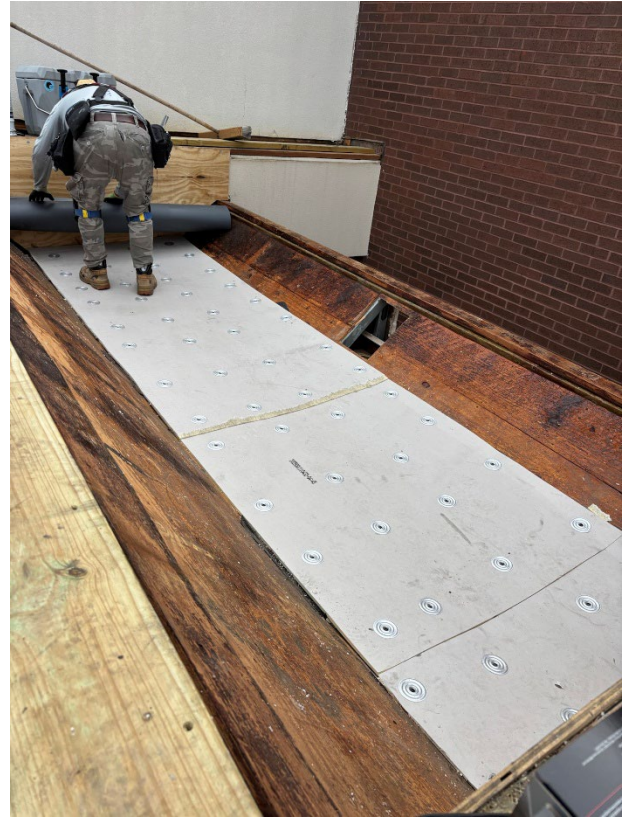
The existing roof system consisted of a ballasted EPDM membrane with deteriorated metal flashing and coping. While the existing barrel roof remained in good condition, it was not properly terminated at the adjacent masonry wall. This created an opening for excessive moisture intrusion beneath the barrel roof, particularly over exposed ceiling areas.

The building's existing internal drains also presented a significant challenge. Damage to the drain lines within the structural columns meant repairs would have required extensive demolition, including removal of brick, concrete sidewalks and asphalt pavement to access the connected stormwater drainage system. Rather than take on an uncertain and invasive repair, Highland's team developed a new drainage solution that could be incorporated into the replacement roof system.

Highland Roofing removed the existing ballasted EPDM system, deteriorated flashing and coping before installing a new 60-mil mechanically attached TPO roofing system.

To improve drainage, the team cut new openings through individual roof sections and installed tapered ISO insulation to direct water toward newly created drainage points. Custom-fabricated through-wall clad scuppers were installed to provide a reliable path for water to exit the roof system, while secondary drainage was added where none previously existed.

The project also required extensive custom metalwork. Highland's Wilmington ES-1 certified metal shop fabricated the new metal coping, through-wall scuppers, conductor heads and downspouts in-house. The sidewall metal flashing at the existing barrel roof was custom fabricated in the field by one of Highland's master metal roof installers, allowing the team to create a proper transition between the existing barrel roof and masonry wall.

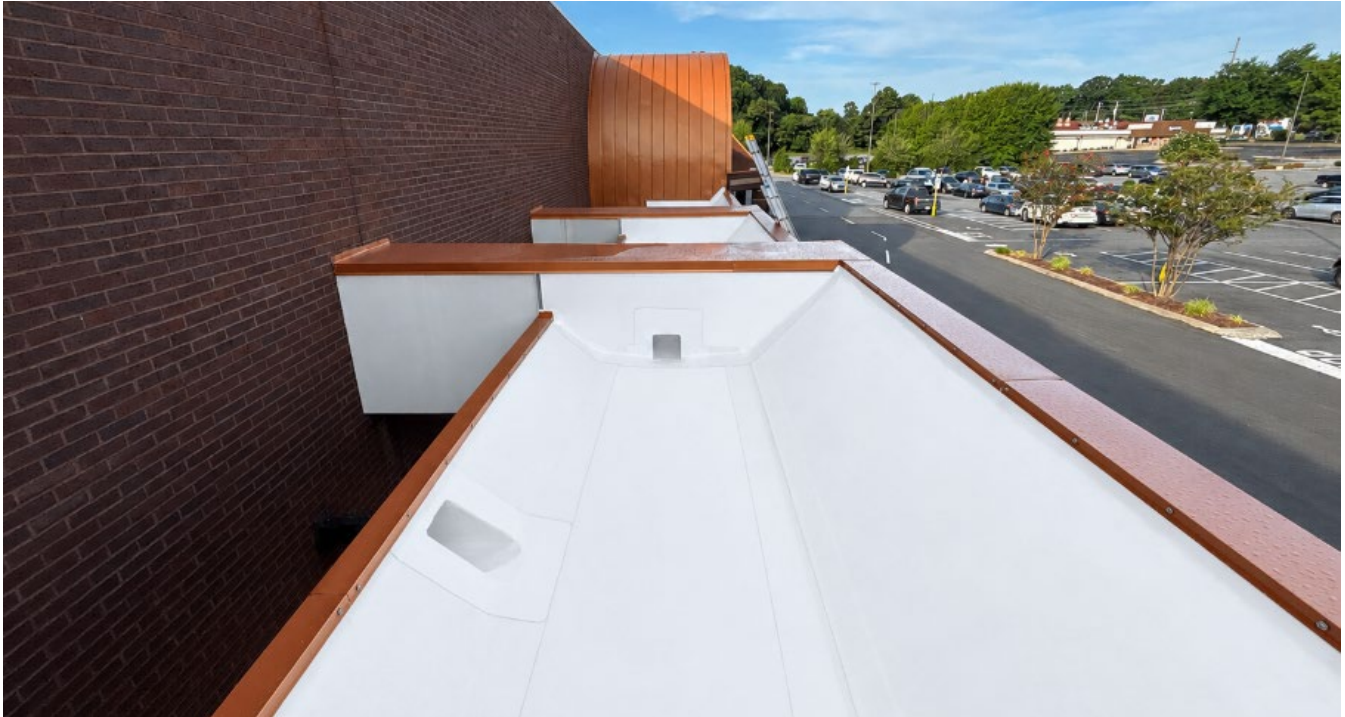
The result was more than a new roof - it was a redesigned drainage and flashing system that addressed the building's existing vulnerabilities and provided a more reliable, long-term roofing solution.
